Collapse of the World Trade Centre Towers

Written by G Charles Clifton,
HERA Structural Engineer

17th September 2001, revised 19th September, minor revision on impact force made 8th October, minor revisions made 11th December.

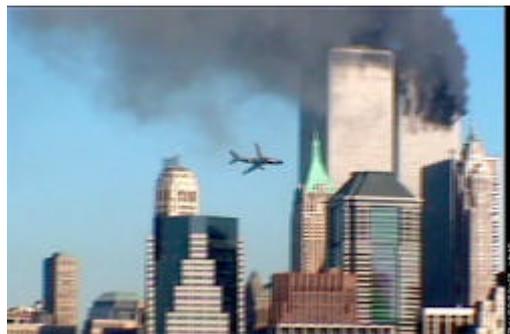
Fig. 8
Plane About to Hit South Tower
(Photo from CNN)

Each tower was hit by a Boeing 767. The impact on the North tower was near the centre of the North face at around the 95th storey, with the plane hitting the side of the building square on and flying level. The impact on the South tower was some 15 storeys lower, with the plane hitting the South face near the South East corner and impacting at an angle to the face of the tower. Fig 2 shows the impact directions and Fig 8 shows the plane about to hit the South Tower.

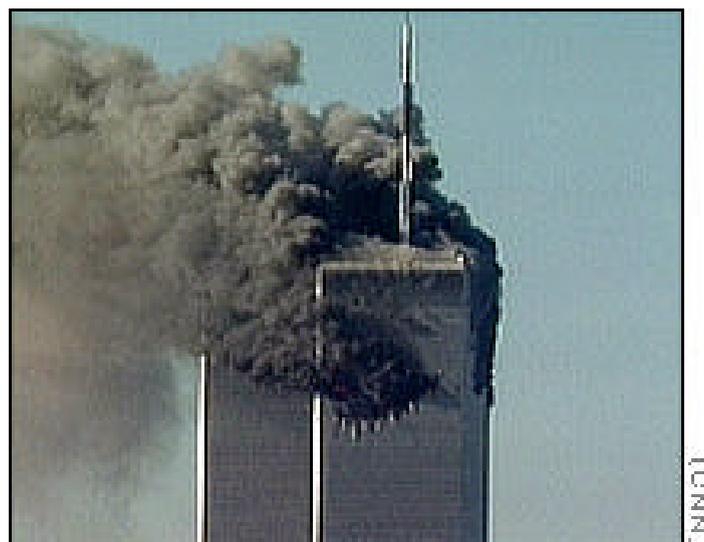
Fig. 9
North Tower After Impact Viewed From the Impact Side
(Photo from CNN)

Fig 9 shows the view looking into the impact hole. Given that the floor slabs are at 3.66 m centres and the façade column centres are at 1.03 metre centres with façade window widths of only 0.48 m, the number of façade columns and perimeter beams severed by the airplane in its passage through the perimeter frame is considerable. From the major damage to the side opposite the impact it is also apparent that much of the airplane would have passed through the core.

It is likely that the impact destroyed most of the floors, at least on the impact side, and the core on at least three levels, removing many of the core supporting columns, at least on the North side of the core, and leaving the remainder buckled and stripped of their passive fire protection.

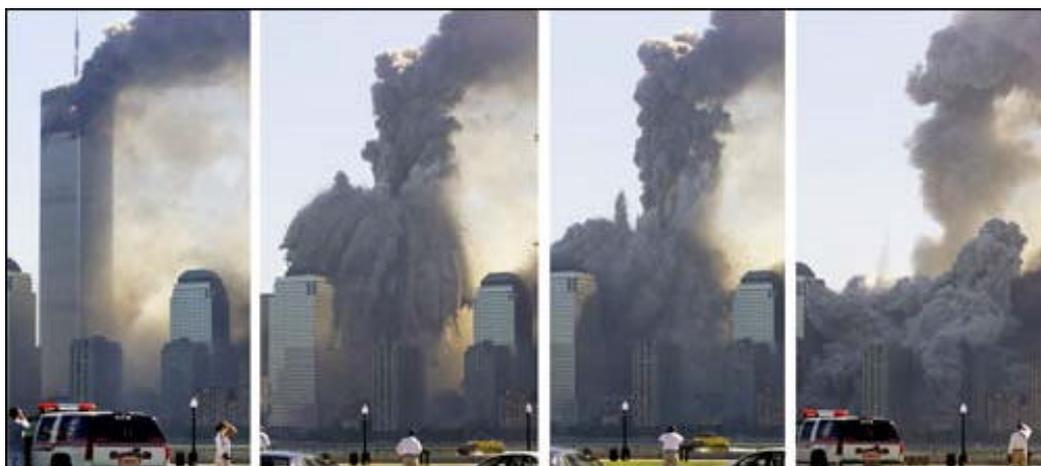
Fig. 10
Sequence of Collapse of North Tower
(Photo from CNN)

Finally, it is likely that the interconnection between one or more floors and the perimeter frame failed at or near the top of the building. This would have resulted in the immediate collapse of these floors. From the video footage this collapse appeared to occur uniformly around the building and spread very rapidly down to the floor above the impact region. That region then pancaked causing a brief gout of flame to be expelled most noticeably from around the South and East sides as the areas within the impact region still on fire collapsed.

The collapse then continued down the building, with the floors pancaking leaving the perimeter frames briefly standing unsupported until they too collapsed. The effect of the floors pancaking nearly straight down inside the perimeter frames lead to the North tower effectively imploding, with some sections of the perimeter frame remaining standing unsupported for a few seconds before collapsing. This is seen from a number of video footages and pictures, including the collapse sequence shown in Fig 10.

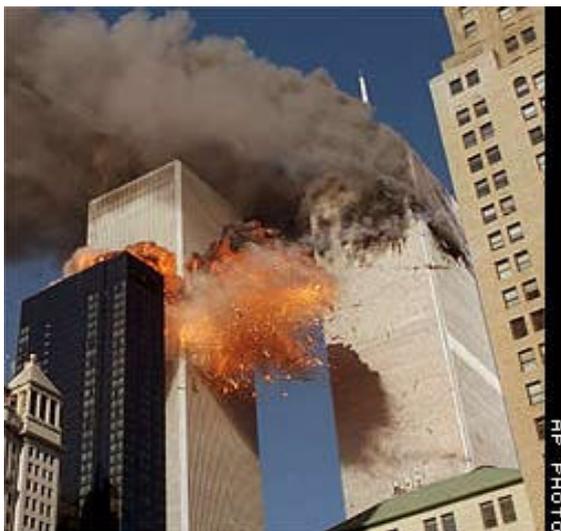
Fig.11
Fireball From Impact on South Tower
(Associated Press photo)

At 9.03 am the plane impacted the South side of the south tower towards the South East corner. It struck the building at an angle across that corner and on a slight downwards heading, as shown in Fig.2. The plane passed into the building and then exploded out of the adjacent East side, causing a large fireball to erupt from both the entry and exit sides adjacent to the South East corner. Fig. 8 shows the plane immediately before impact and Fig 11 shows the expanding fireball erupting from both sides of the building.

In contrast to the North Tower impact, in the case of the South Tower only one corner of the core would have been directly in front of the plane's path through the building, along with the floor slabs over several levels in the South East corner. It is likely that the initial impact destroyed all the floor slabs in that corner over at least four levels and maybe over as many as six. It would have also severely damaged the South East corner core, removing an unknown number of columns there, buckling many more and destroying most of the core walls (which are drywall construction). We do know that at least one stairwell in the core remained intact after the impact, as there have been five survivors from the floors above the impact floor who must have had access to an intact stairwell to escape.

Immediately after the impact the perimeter frame in the South East corner would have been severely weakened, being reduced to an unknown number of intact box columns in towards that corner on each of the two sides. However, these columns would have lost the lateral support from the floor slabs over many levels and would have had to function as isolated columns spanning multiple storey heights. They would likely have suffered blast damage and loss of alignment, however immediately following the impact they still retained sufficient compression capacity to resist their share of the loads from the 30 or so floors above the impact region.

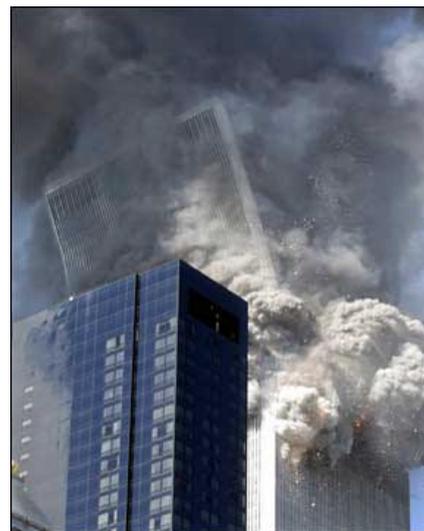
Fig.12
Top of South Tower Collapsing
(Photo from CNN)

Finally the combination of increasing compression load on these damaged columns, with second order effects from this load acting on the buckled shape of these columns over their unsupported length, would have caused their collapse. This collapse would have initiated in the damaged corner and spread rapidly over the impact region, causing the tower above to fail by toppling sideways with the floors above the impact region momentarily in an intact condition. This stage of the collapse is shown in Fig. 12.

However, even with the top floors toppling sideways, sufficient material would have impacted straight down on the floors below the impact region to have caused these to start to pancake downwards, leading to the tower below the impact region collapsing in much the same manner as the North tower.
