Collapse of the World Trade Centre Towers

Written by G Charles Clifton,
HERA Structural Engineer

17th September 2001, revised 19th September, minor revision on impact force made 8th October, minor revisions made 11th December.

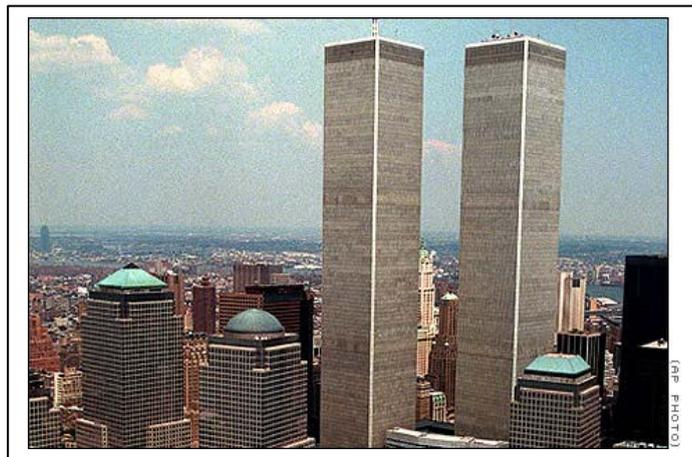
Fig 1
World Trade Centre Towers Before Attack
(Associated Press photo)

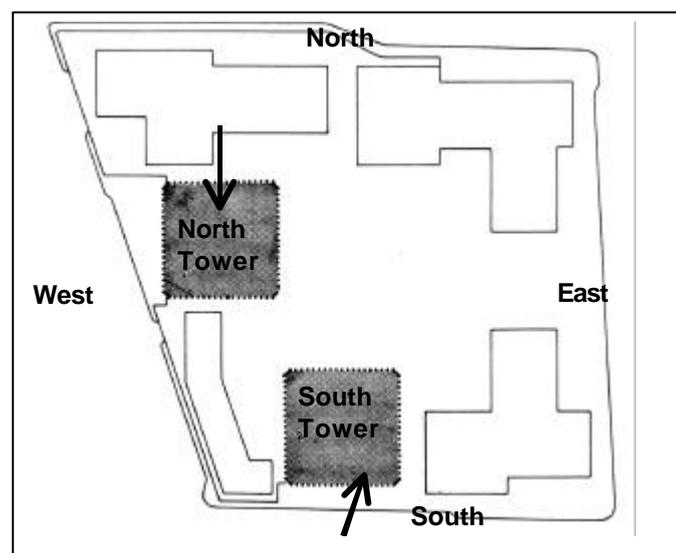
Fig. 2

Site Plan of World Trade Centre Development Showing Location of the Two Towers

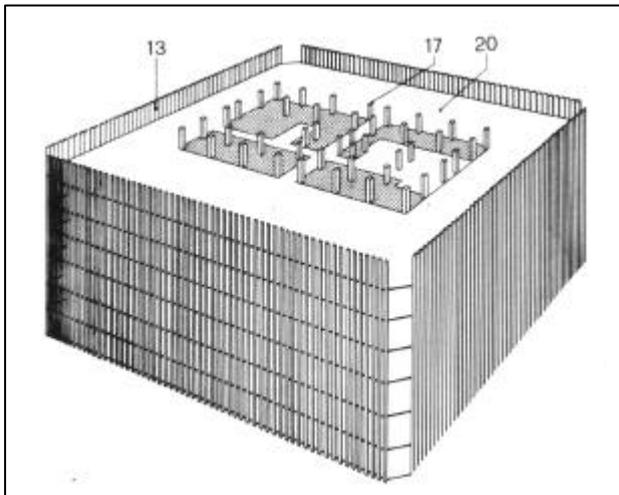
Fig. 3
Isometric View of Building
(from [1])

- 13 – Perimeter frame
- 17 – Core box columns 450 mm square
- 20 – Floor slab

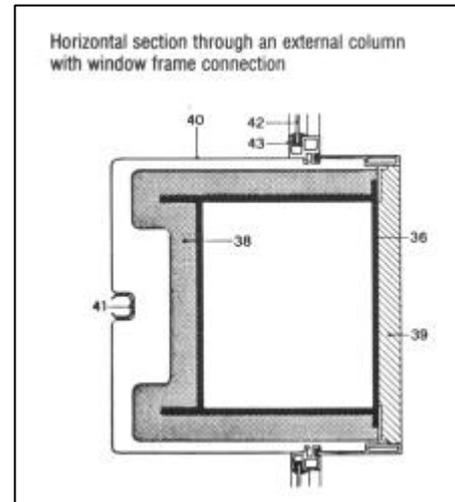
Fig. 4
Cross Section Through
Exterior Box Column (from [1])

- 36 – Steel column
- 38, 39 – Fire resistant plaster
- 40 – Aluminium façade
- 42 – Window glass
- 43 – Window frame
